# A RESEARCH STUDY ON INTERNAL CORROSION OF HIGH PRESSURE BOILERS

## SECOND PROGRESS REPORT

Steam and Water Division  
Kreisinger Development Laboratory  
Combustion Engineering, Inc.  
Windsor, Connecticut

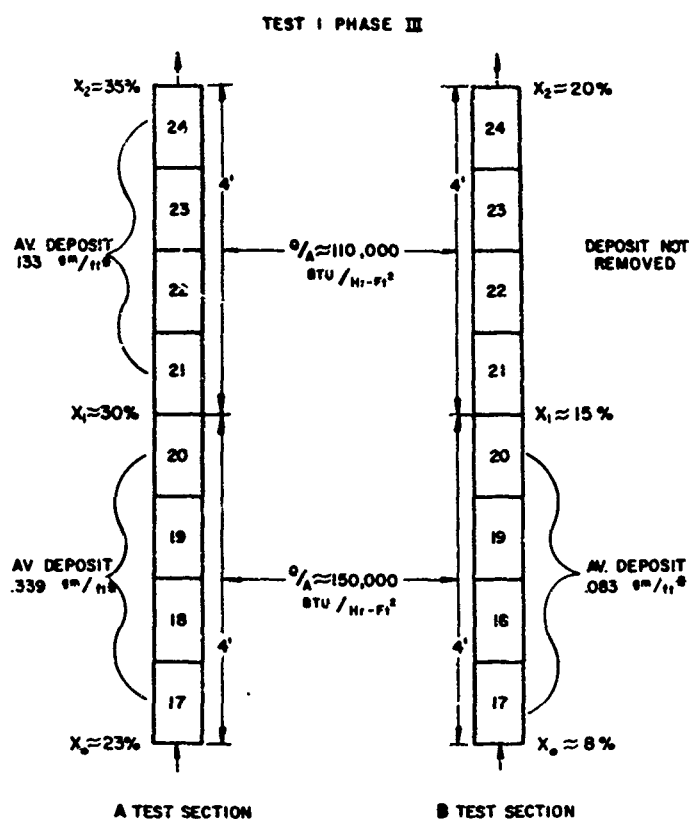
The data collected from the clean-boiler and dirty-boiler tests respectively, reveal consistent trends in the distribution of deposits with relation to heat flux and quality. Figures 4 and 5 illustrate the typical distribution among the various portions of the A and B test sections. The values listed are average deposit weight per linear foot as removed from the heated side of tubing. Data in Fig. 4 indicate the maximum accumulation of deposit in the high-heat-flux section of the A loop. This area and the lower-heat-flux section of the same loop both accumulated more material than the surfaces of the high-heat-flux zone of the B test section. Figure 5 breaks down the distribution of deposit in a high-heat-flux section, revealing an increase in quantity of deposit with mixture quality. The deposits referred to in Figs. 4 and 5 were primarily composed of contaminant materials. These results indicate that deposition of suspended magnetite and metallic copper increased with both increasing heat flux and mixture quality.

Fig. 4: Typical deposit distribution of both the "A" and "B" test sections

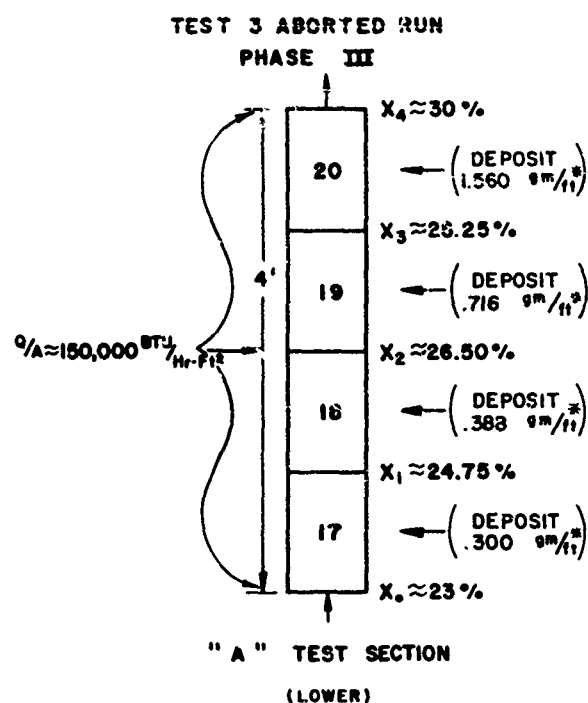
Fig. 5: Typical deposit distribution on a high-heat-flux "A" loop test section

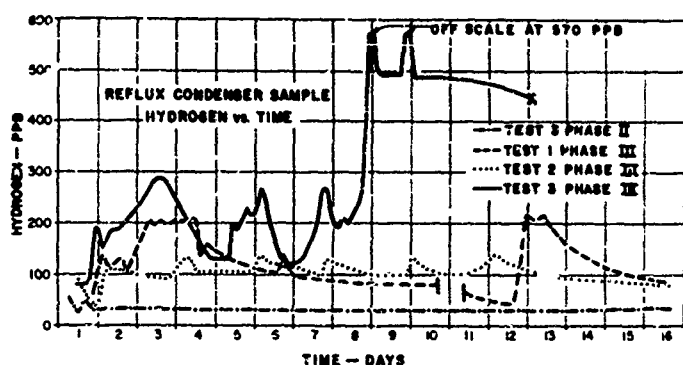
Fig. 6: Comparative plot of hydrogen evolution data from 1 "clean boiler" and 3 "dirty boiler" tests

test. Hydrogen-evolution data, comparing these three dirty-boiler runs and the clean-boiler caustic test, are shown by Fig. 6.

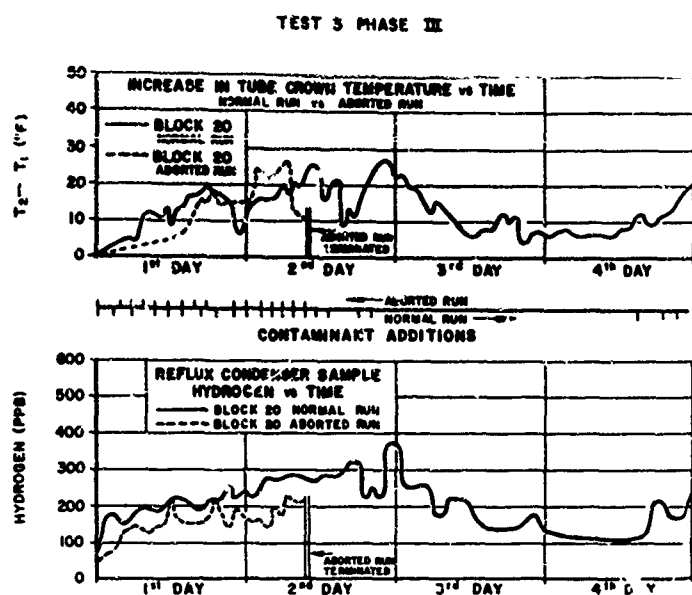
The two curves, shown in Fig. 10, compare the temperature rise and hydrogen evolution of the completed run with the results of an aborted run with the same water environment and degree of surface fouling. It is significant that both curves reveal a similarity of response to contaminant addition in both rate of increase and

**Fig. 10: Comparative plot of tube crown temperature and hydrogen evolution from the aborted and completed "dirty boiler" caustic runs**

Temperature rise and hydrogen evolution curves have been prepared showing comparative values from the aborted and completed caustic tests (Fig. 10). The duplication of general response shown by these curves indicates a similarity in the initiation of corrosion by the accumulation of contaminant materials on the test surfaces.
